MCF5282 Chip Errata

Silicon Revision: All

Document Number: MCF5282DE
Rev. 8, 02/2015

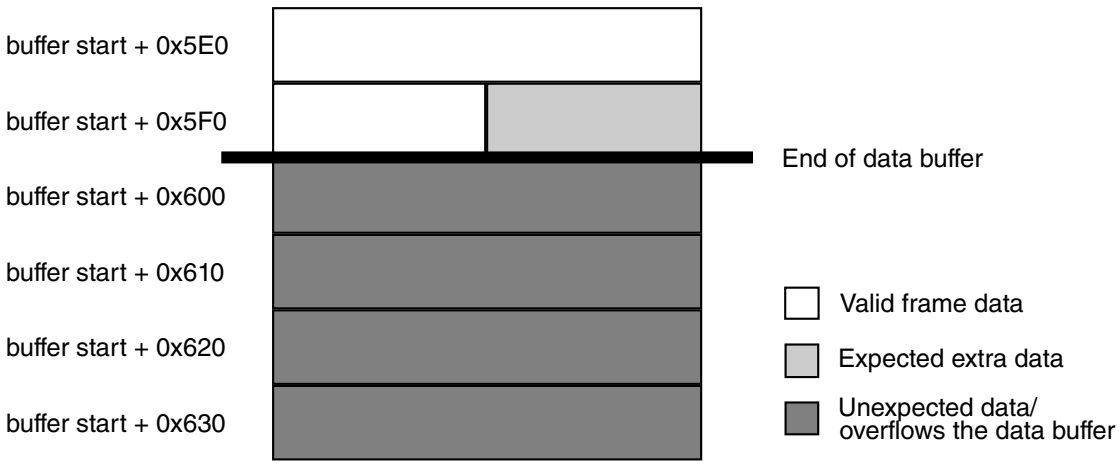
Figure 1. Buffer Overrun Example

SECF009: FEC Receive Buffer Overrun in 10BaseT Mode

For example, as shown in the figure below, if the max buffer size is programmed to 0x600 and a frame that is 0x5F8 bytes long is received, a line is written starting at buffer start + 0x5F0. The first half of the line at buffer start + 0x5F0 is valid frame data that should be processed by the FEC driver; the second half of the line is additional data that is written because the FEC only writes complete lines. This data should be ignored by the FEC driver. So far, this is correct FEC behavior as originally specified. However, the FEC repeats the last line of valid data a number of times. The line at buffer start + 0x600 is written, and as many as three additional lines beyond the end of the data buffer could be written.

Workaround: Only use 100BaseT.

Workaround: Allocate extra lines for the receive data buffers. The actual allocated memory for each buffer should be equal to the receive buffer size programmed in the FEC's EMRBR register plus four lines (16 byte-sized lines).

Workaround: Program the data buffer size one line larger than the max packet size (data buffer size = EMRBR + 0x40).
